PHASE I INSPECTION REPORT
NATIONAL DAM SAFETY PROGRAM
TENNESSEE

Name of Dam Chancellor and Son

County Hardeman

Date of Inspection March 10, 1981

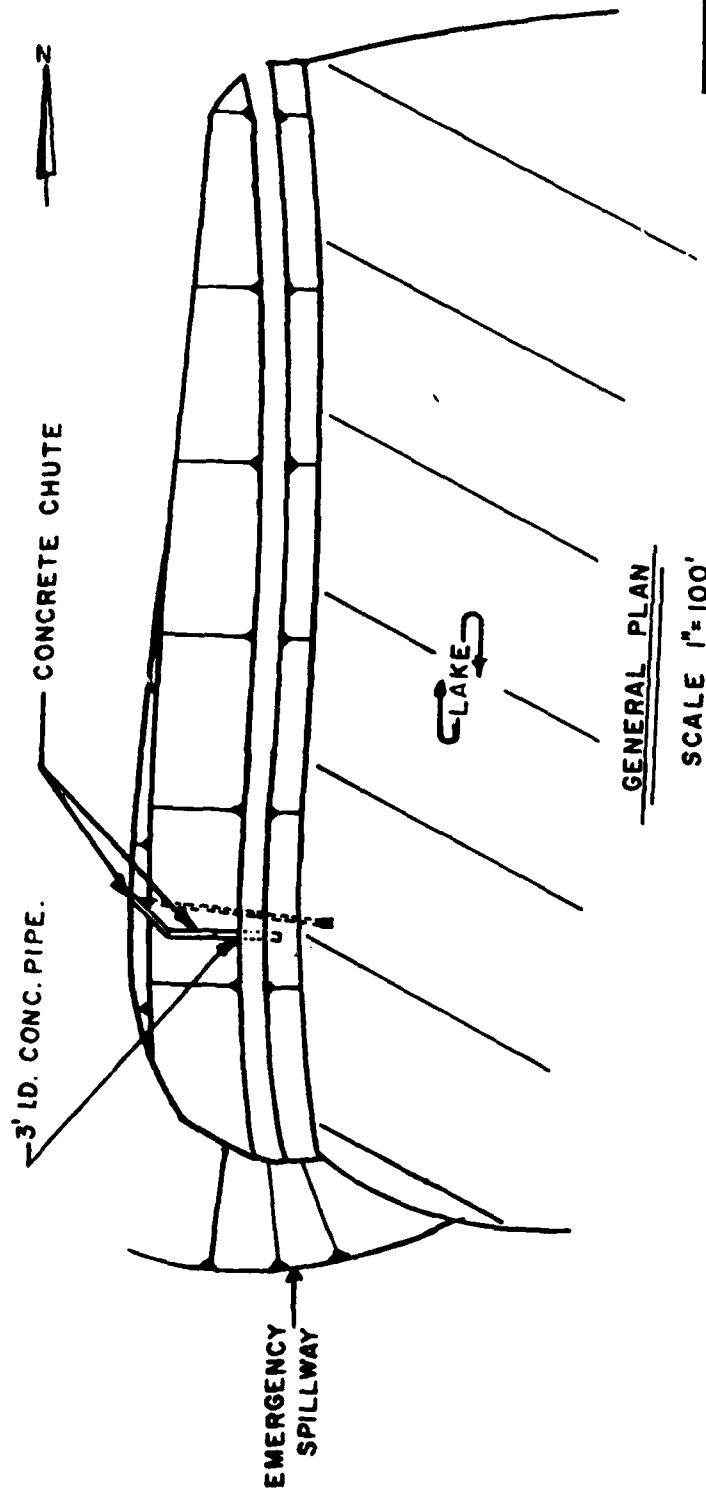
CHANCELLOR DAM	
DRAWN BY ADP	
DATE 7/2/81	
SHEET 1 OF 4

3.1.1 A flow of about 2-3 gpm is emerging from the area around the end of the service spillway chute and the left embankment abutment contact (photos 11-13, sketch p. 1 of 4). The owner reported that a spring was located in this area prior to construction of the dam. The water has been discolored by FeO_2 . There is no clear evidence indicating that the water is transporting embankment material due to the erosion deposits in the area from the abutments. About 1 gpm is emerging around the exterior of the toe drain outlets. No distinct sources could be pinpointed for the remainder of the flow.
